**PHASE I
ENVIRONMENTAL SITE ASSESSMENT REPORT**

GASOLINE STATION
LITTLE GENERAL FOOD MART
500 EAST MAIN STREET
HAMLET, NORTH CAROLINA 28345

JANUARY 28 2008

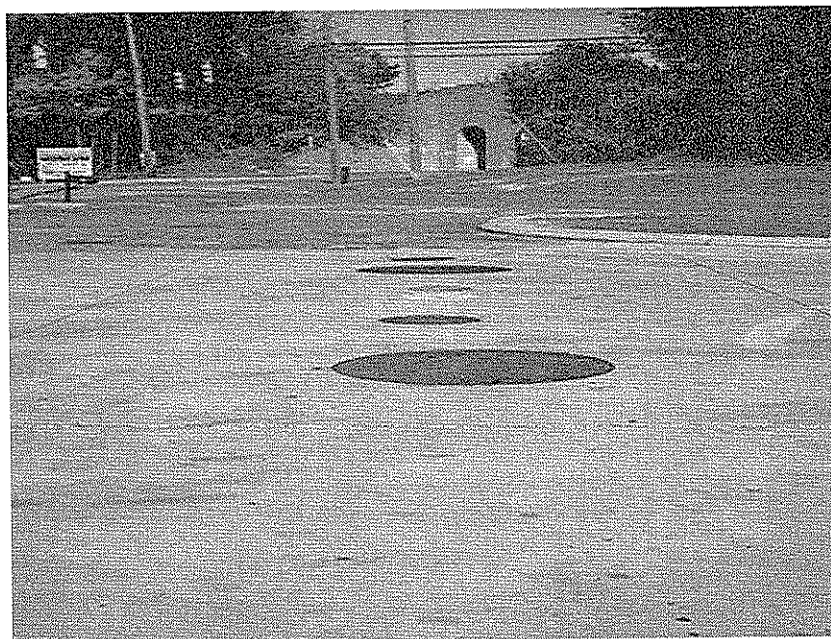
Based on an interview with the NCDENR, one dual-compartment 4,000- and 8,000-gallon UST was installed on the eastern portion of the subject property in January 2006. No records regarding UST and associated piping tightness tests being performed on the subject property were found. No additional information regarding the active USTs was available. It is possible that a release associated with these active USTs could have occurred.

Photo 3 - View looking at approximate location of the underground storage tanks (USTs) located on the northeastern portion of the subject property.

Based on these findings, AAI recommends that appropriate leak-detection monitoring should be conducted on the underground storage tanks and associated piping, according to federal, state and local standards, including tank-tightness testing.

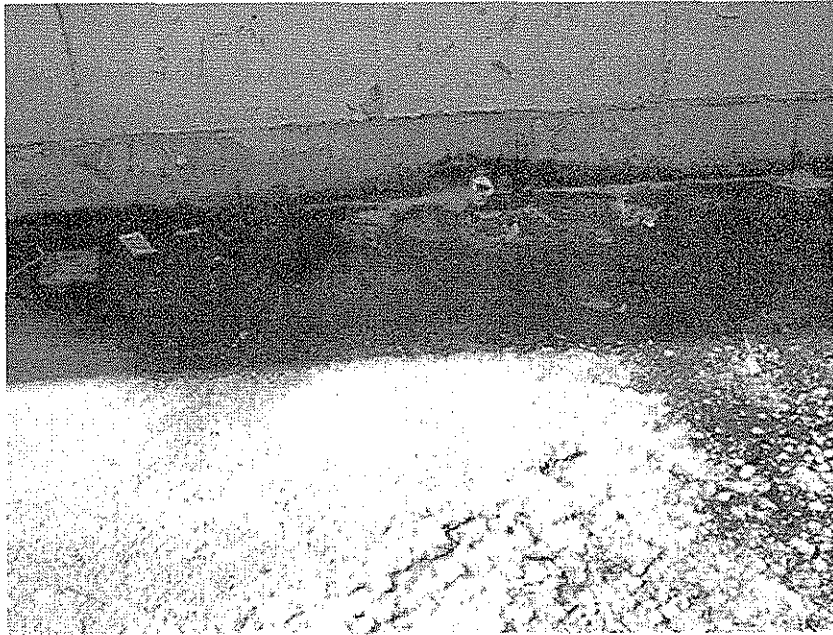
Discharge was observed adjacent to the southern portion of the subject property building. The source and contents of the discharge could not be identified.

Photo 5 - View looking at the unknown discharge located adjacent to the southern portion of the subject property building.
